**SUPERIOR COURT OF THE DISTRICT OF COLUMBIA  
CRIMINAL DIVISION—FELONY BRANCH**

**Government’s Motion to Dismiss the Indictment**

### **I. The Initial Information Provided to the Government**

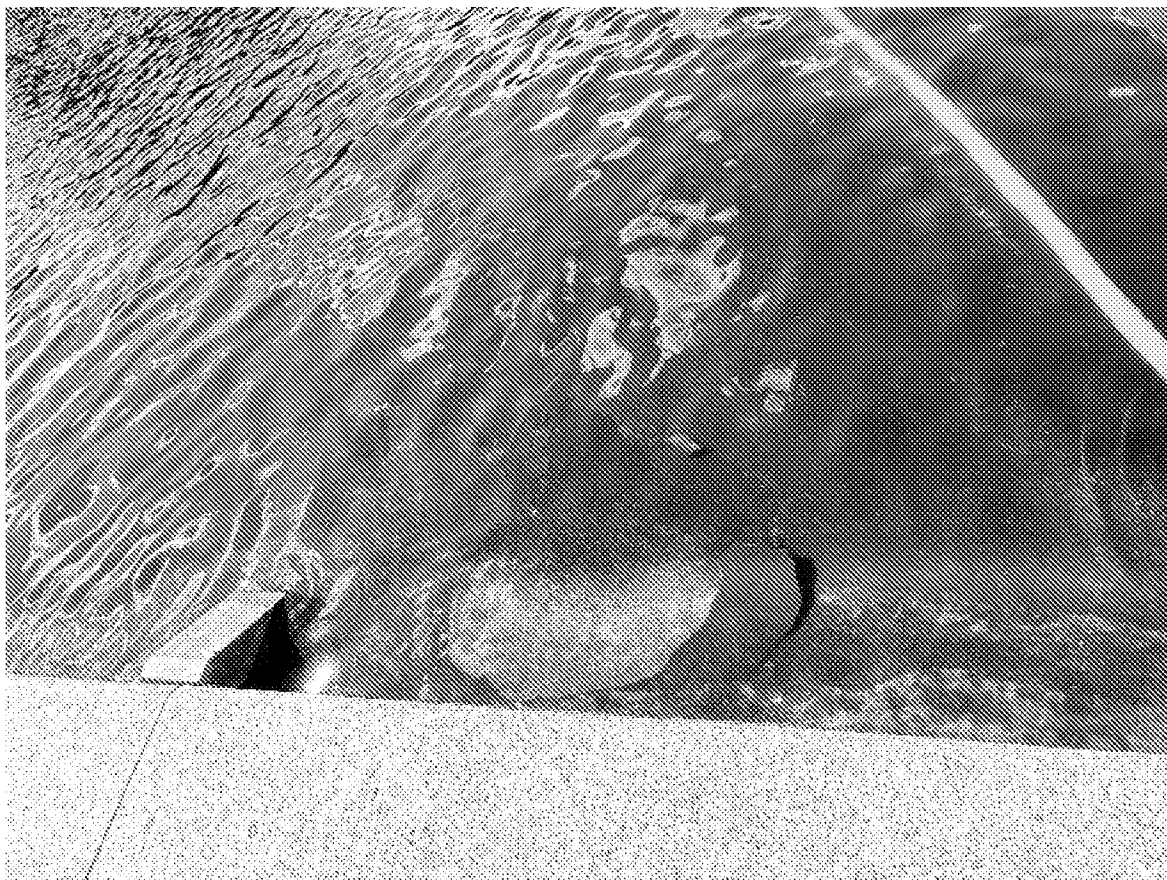
The photograph below was taken by NPS employee W-1 after the incident involving Hearn. Metadata associated with the photo indicates that it was captured on June 19, 2026, at 4:48 PM. A review of USPP body-worn camera shows the officers speaking with the defendant at 4:40 PM.

W-4, an employee specializing in maintenance and repairs employed by the National Park Service, stated that repairing the additional damage caused to the reflecting pool based on the defendant's conduct would cost over \$1000. DOI represented that nearly all of the damage to the Reflecting Pool was due to vandalism with only a small portion due to unidentified other causes.
